**SPREP**

# Asbestos Contaminated Materials Guide for Disaster Debris Removal

April 2020

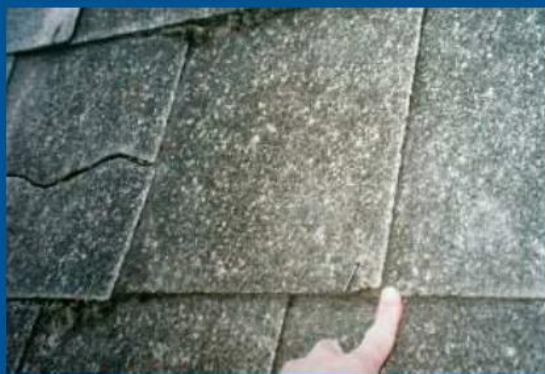
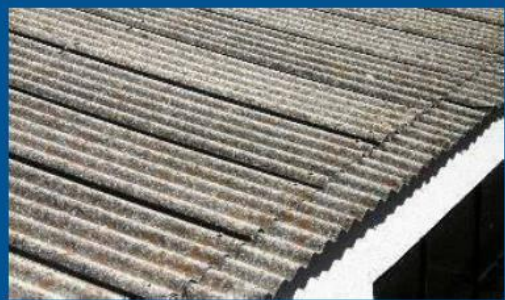
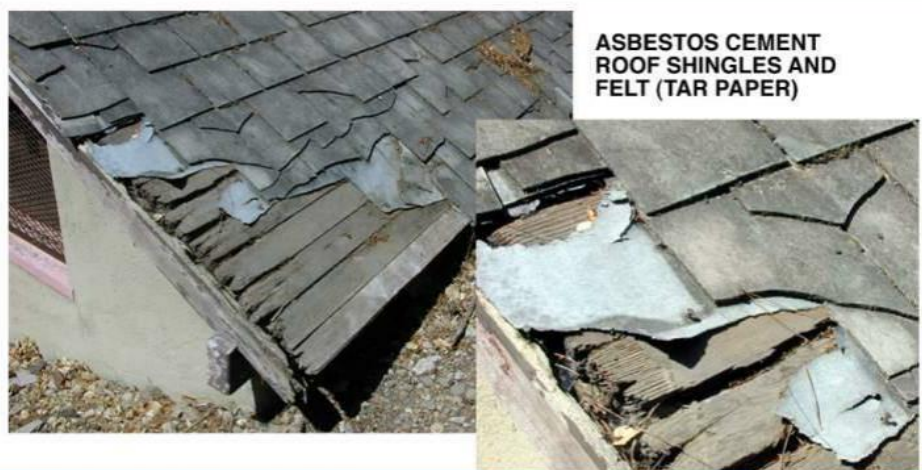
## Asbestos Roofing Material — used from 1920's to 1970's
